SUFFOLK YACHT HARBOUR

Saltmarsh management scheme 2014/5

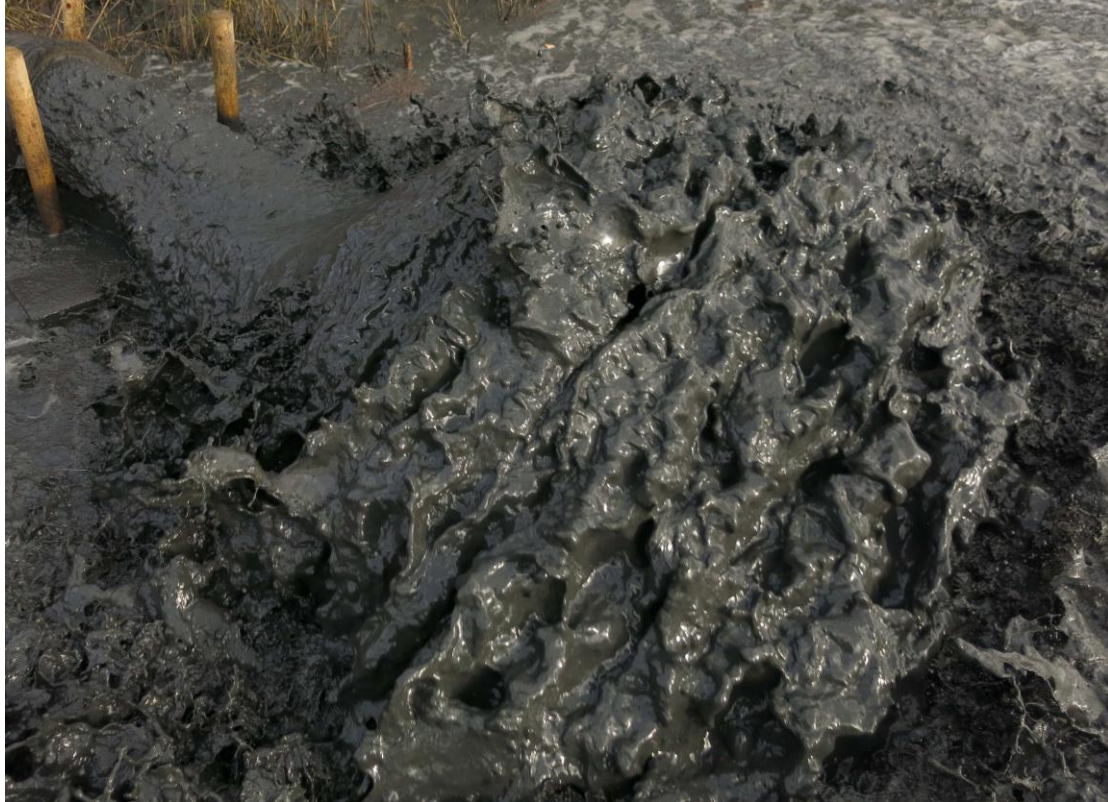
Discharge point at Loompit Lake

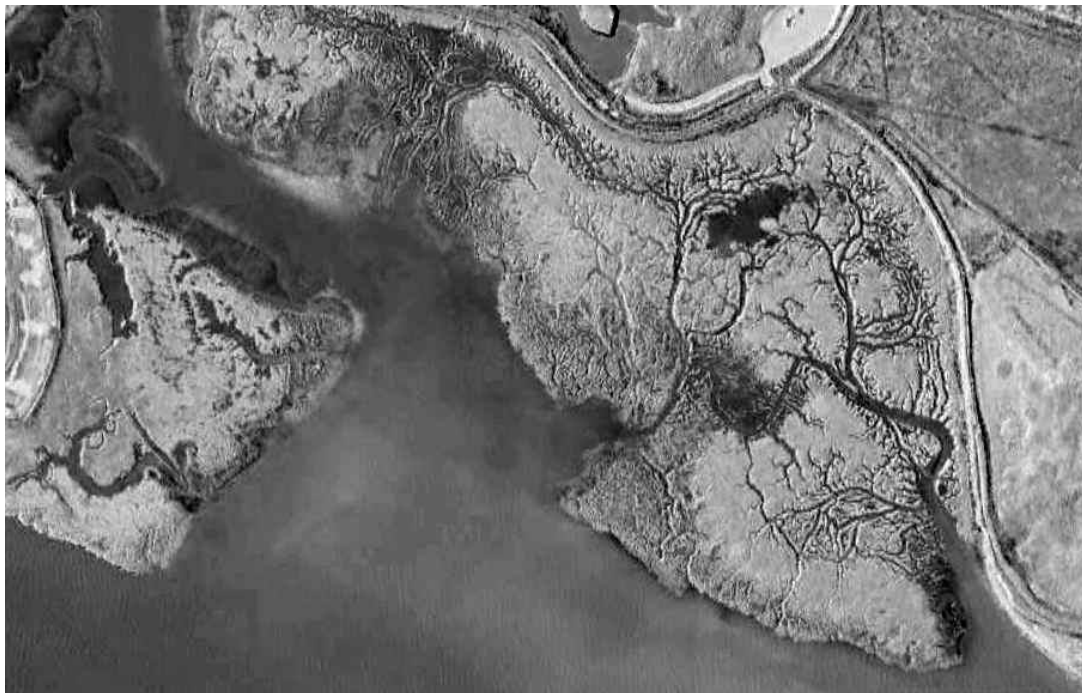
North Marsh, reversed to show channel complex.

The relative levels of the drain channels and the crest of the saltmarsh are very slight, frequently less than 500mm. Since it does not make sense to install structures reaching beyond these dimensions, we decided to work exclusively with Coir Logs staked directly into the channel bed to impede flow and facilitate the deposition of sediment during the dredging operation. Our approach to this was:

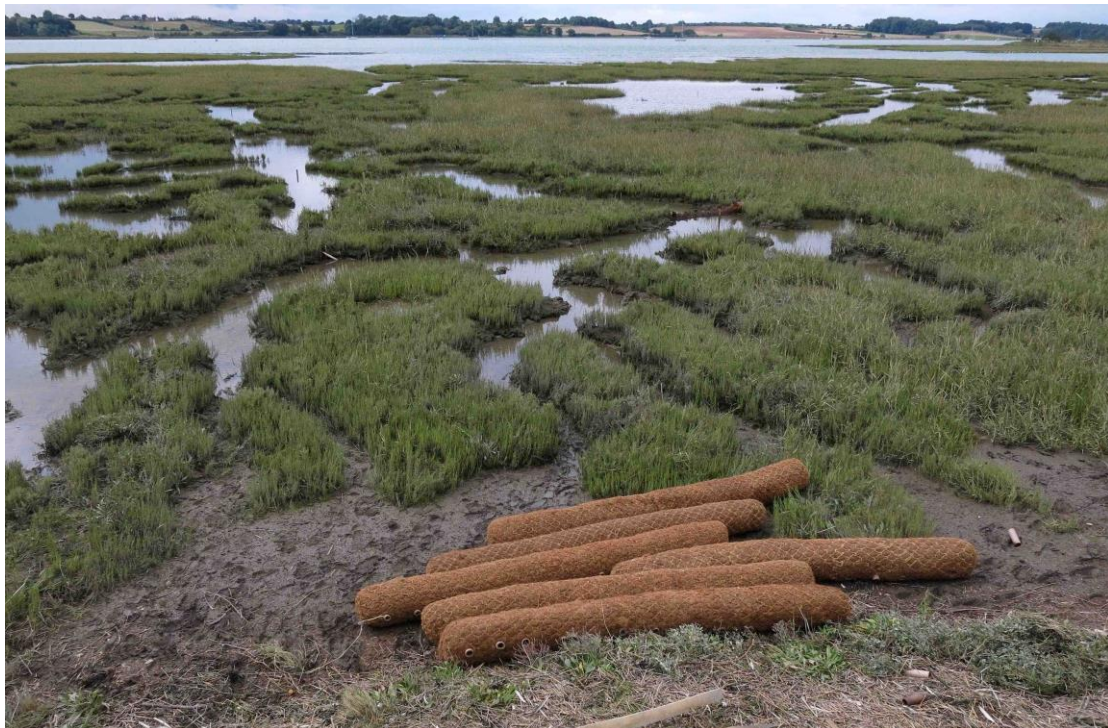
Coir Logs to be located in the channel system

- Map the site and discern the gradients and direction of flow within the marsh.
- Strategically place Coir Logs within the system to incrementally interrupt flow, but avoid the build up of bodies of standing water sufficient to increase hydraulic pressure to the extent that it will cause failure either through undermining or diversion.
- In the first instance, 48 Coir Logs were staked into the channels radiating from the proposed discharge point. In an effort to mitigate the effects of higher velocities and levels of flow, these are positioned more tightly together near the point of discharge than at the outer limits of the channel system.
- The installation took 5 days from 18th to 23rd August 2014.

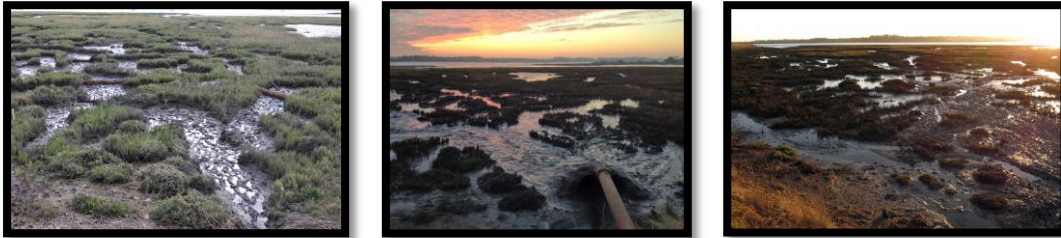
December 19th 2014: After six weeks dredging, the entire channel system within 50metres of the outfall has become smothered by spoil and the coir bunds further downstream are noticeably holding back sediment. After a period of settlement, there will be one further discharge at this site before attention is transferred to the south site beside Loompit Lake.

Channel system, after the installation of coir logs, during and after completion of pumping operation.

Upon completion of this current season's dredging operation, it is anticipated that the spoil will settle and perhaps stabilize with pioneer vegetation (most likely *Salicornia Europaea* and *Spartina Anglica*). If the new sediment has become stable enough, there is potential for a further continuous outlying structure to encourage levels to build and to establish succession.

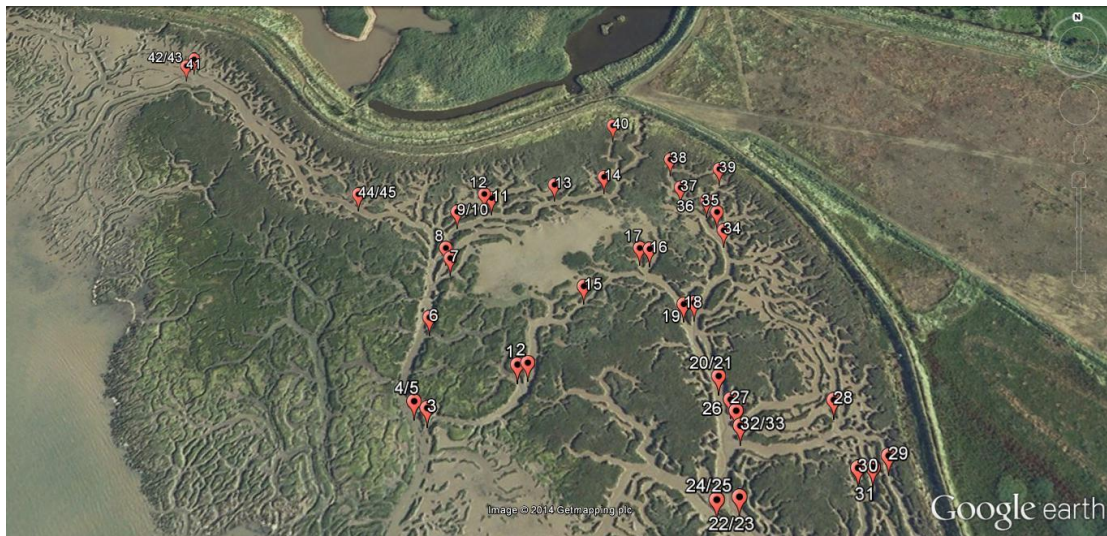
Locations of Coir Logs on North Site

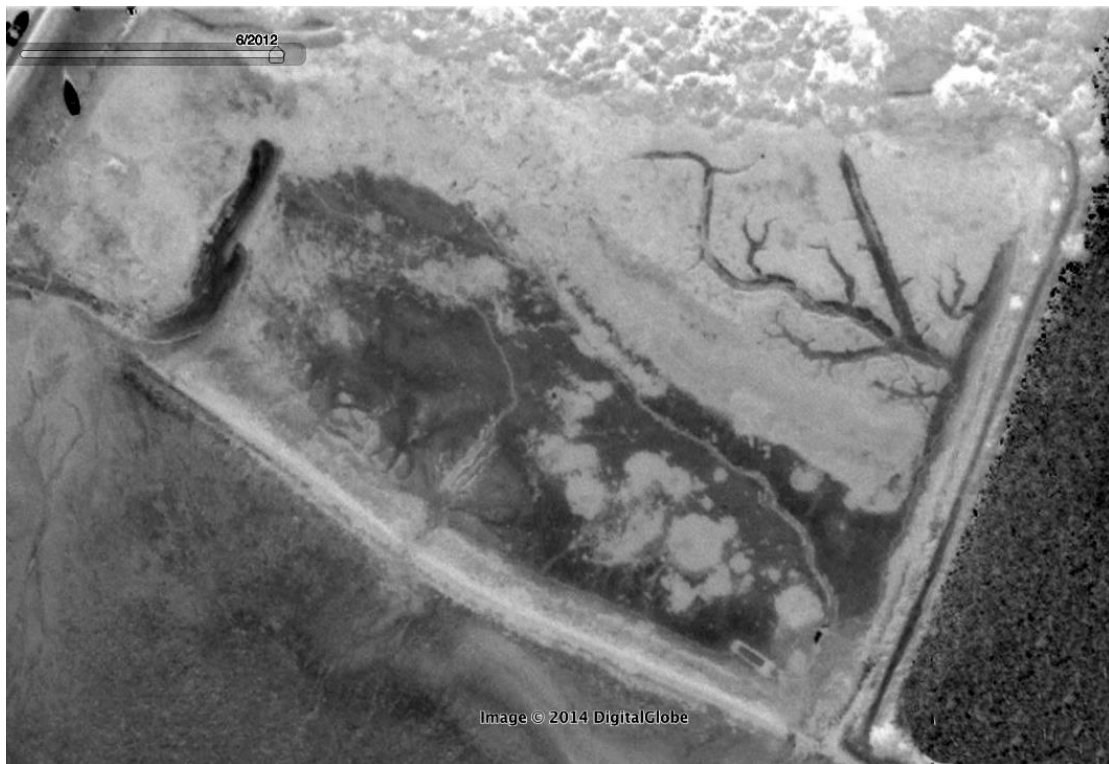
Loompit Lake site reversed to highlight mudflats and channel system.

At present the state of the original sea defence wall is vestigial having eroded back to its riverstone core, no higher than high water neaps. The gradient of the site is oriented roughly northeast southwest; as a consequence it currently drains through two breaches, the main one at the southeast corner beside Loompit Lake and the other at the centre. The strategy for managing the discharge of dredging spoil within the site is threefold:

- Block the two main breaches in the original defence wall to ensure that the spoil will not be carried out directly into the tideway and that tidal exchange within the site will be controlled.
- Construct a pen of brushwood backed up with coir logs using coir blanket around the outfall to mitigate the immediate effects of scour at point of impact.

- Construct a series of low bunds within the site to manage increased flow, discourage the tendency to form substantial drain channels and to encourage deposition as evenly as possible across the site. This is a low-key intervention using coir logs similarly to how they were deployed on the north marsh.

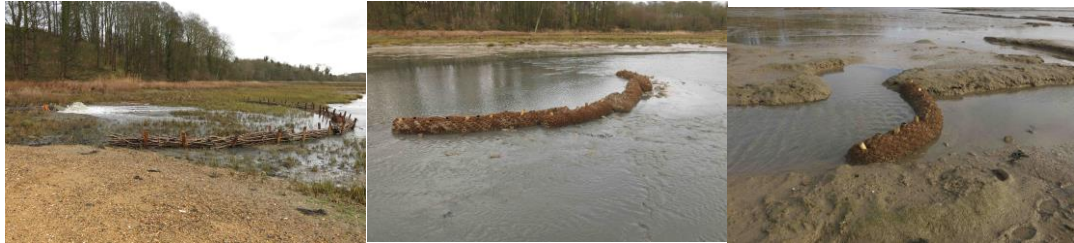
Holding pen at discharge point Coir bund at upper channel Single coir log in small channel

The strategy for the intervention at this site was agreed during Autumn 2014 and installation took place during the weekend of 10th/11th January 2015. Sediment pumping was commenced on site during the week of 19th January. The behaviour of the installation was checked on Monday 26th January and it was seen to be operating efficiently and that flows over the mudflat mitigated well by the complex of coir barriers.

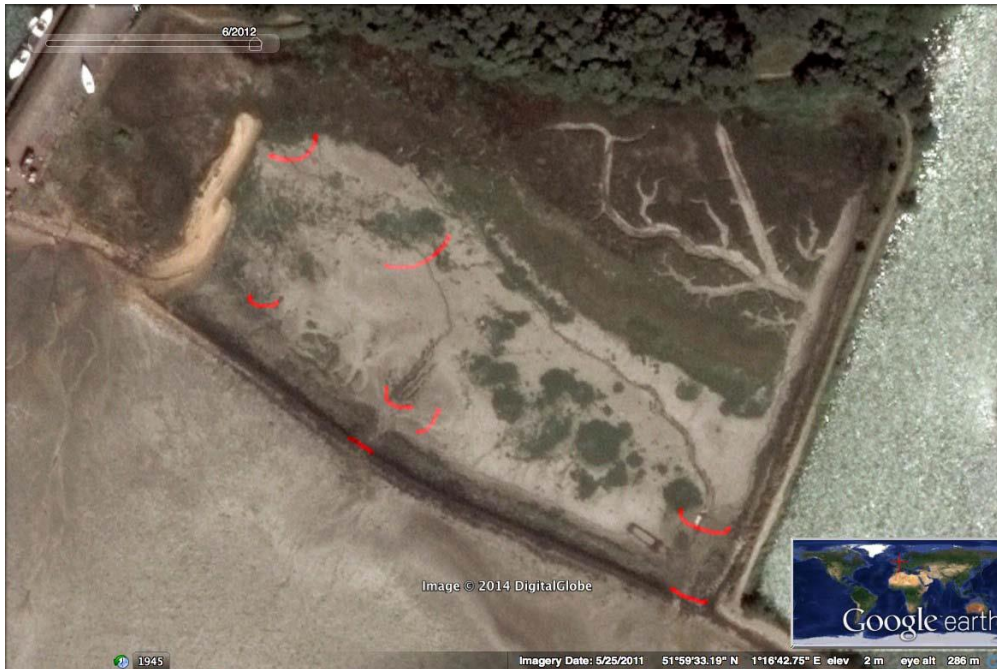
Location of Coir Logs and bunds on the Loompit Site

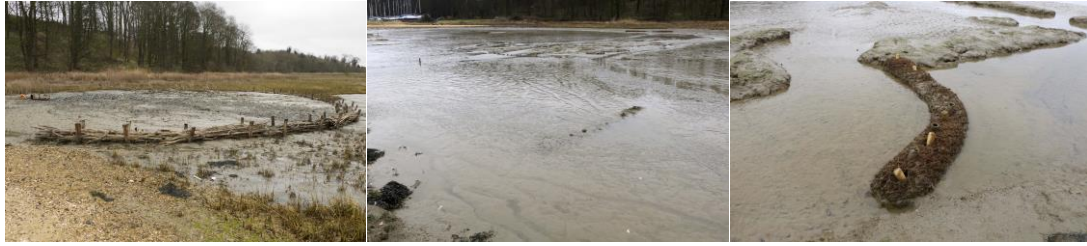
After the completion of the dredging operation at the Loompit Lake site, it became clear that the bunds that had been put in place had been effective in retaining sediment within the site and ensuring that the existing channel systems were not scoured deeper. Once the sediment has settled, it will become clearer whether or not further work will be needed on the site before the next season.

Loompit Lake site after completion of dredging operation, February 2015

There may be a tendency for alternative channel systems to develop on the both East and West sites, however, it is agreed to wait until after the completion of the dredging operation for the current year before deciding upon whether it will be appropriate to install further adaptive measures.

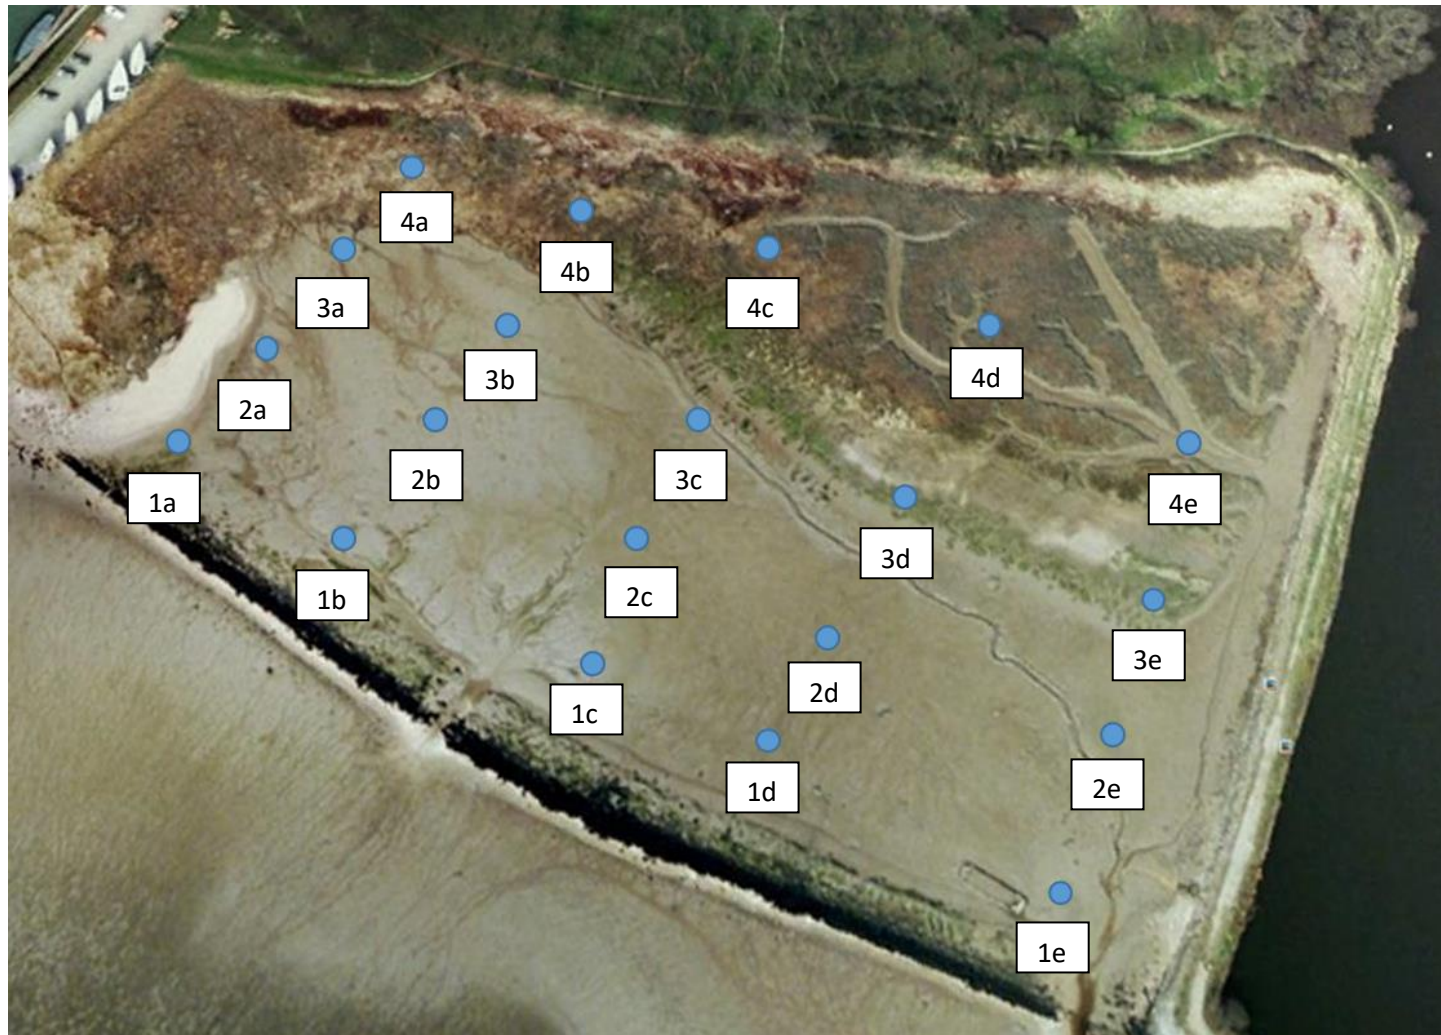
Plate 1. Location of Levington saltmarsh restoration project points – east side January 2015. All stakes set at a height of 500mm.

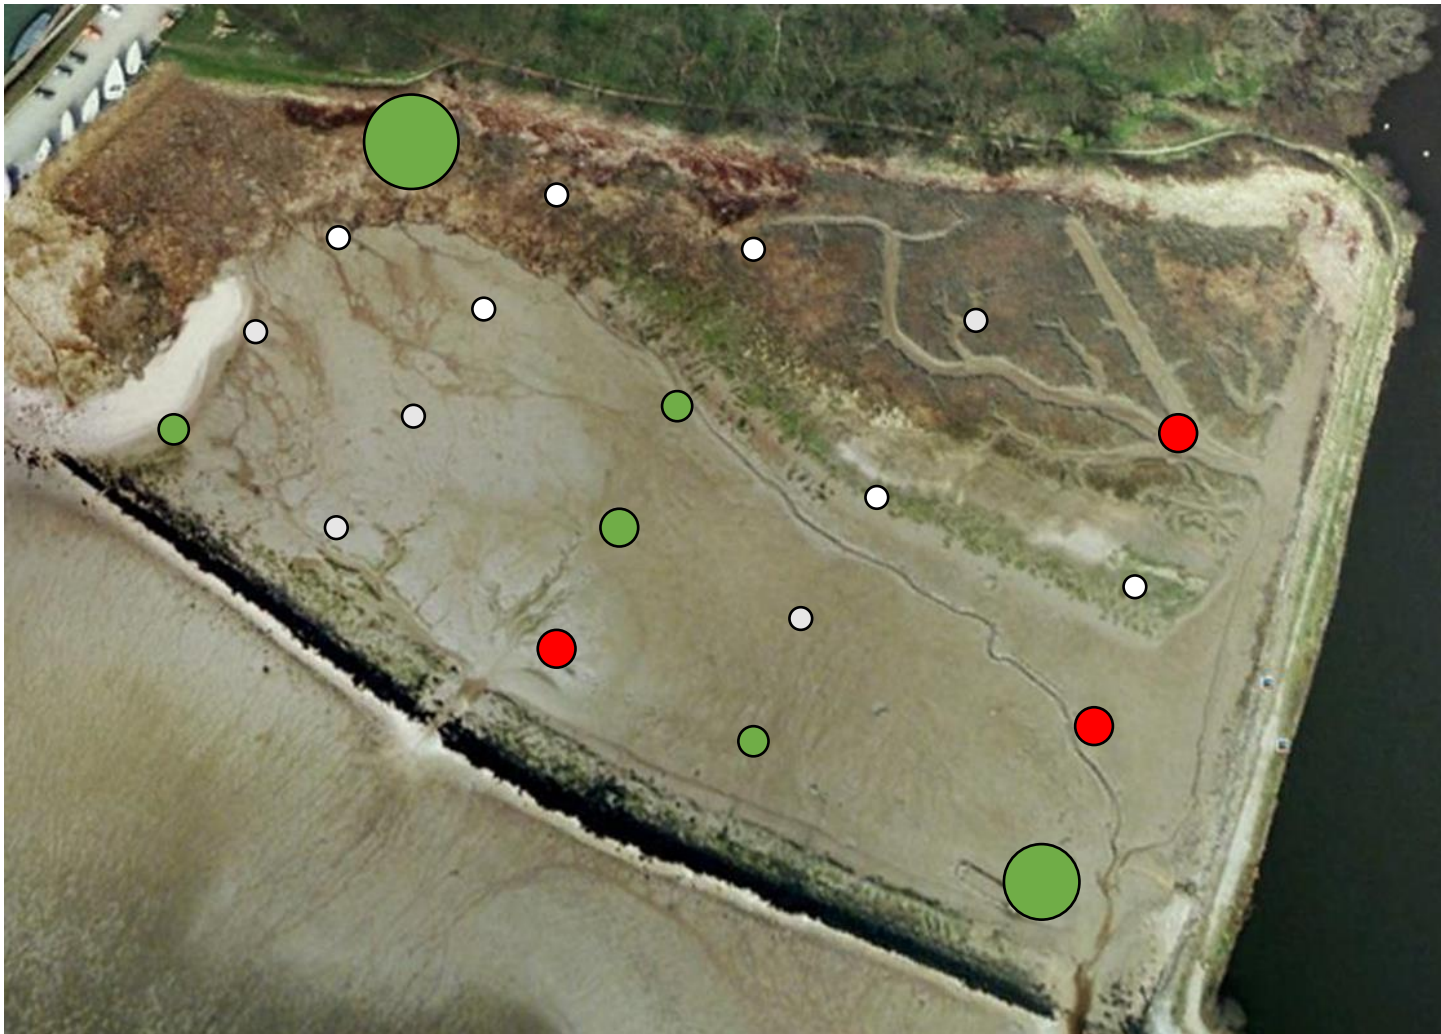
Plate 2. Status of September 2015 east side Levington saltmarsh project points based on January 2015 measurements.

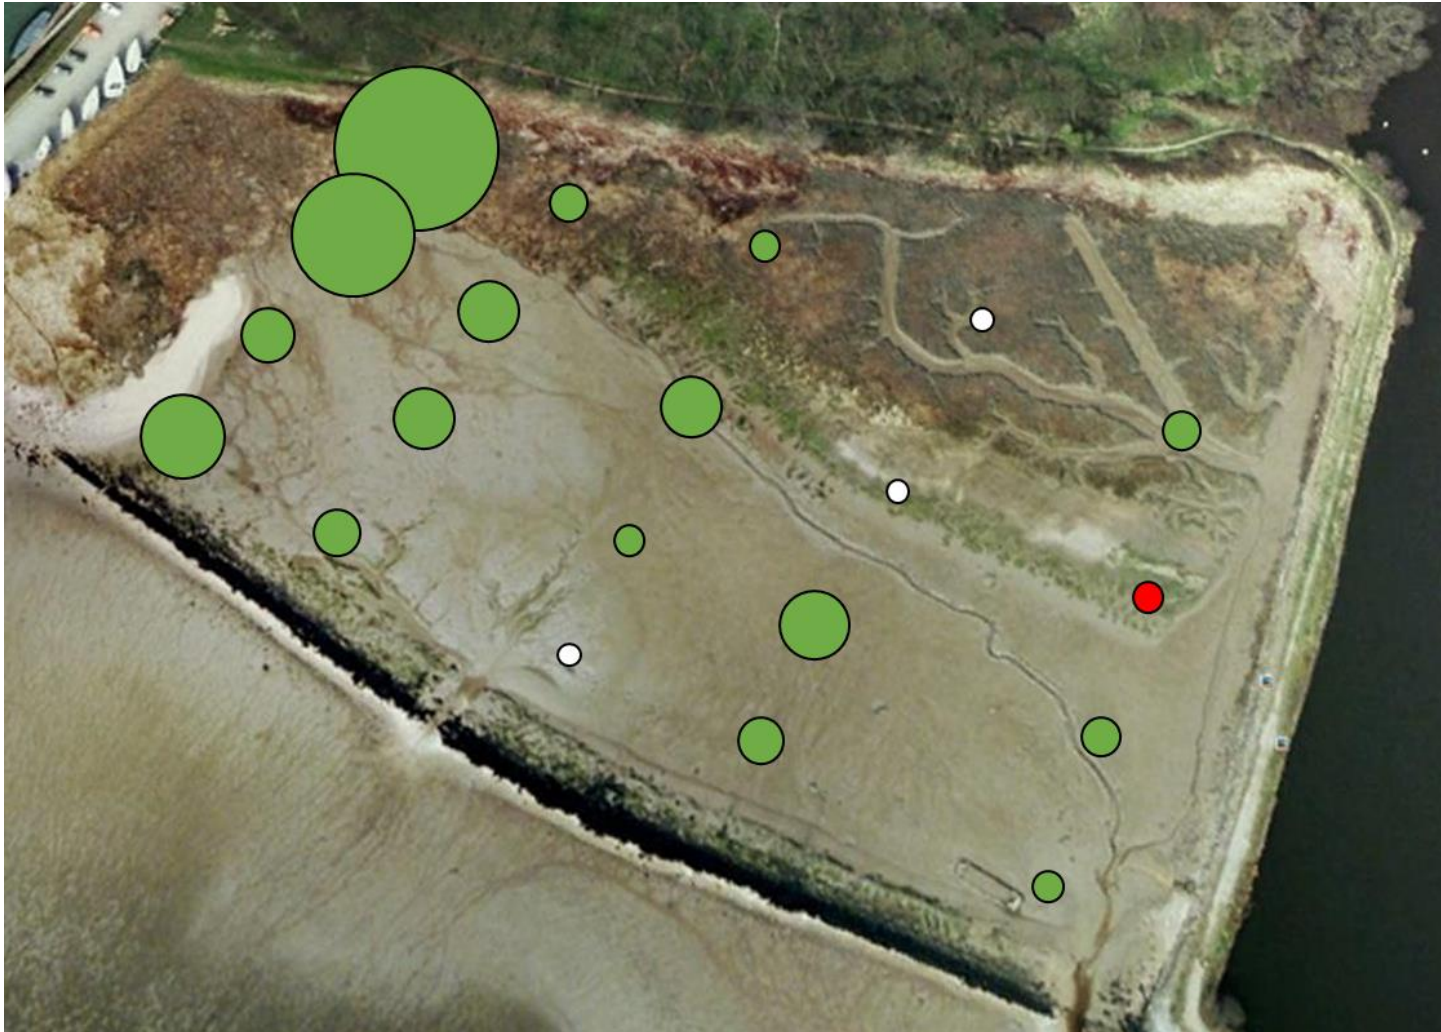
Plate 3. Status of October 2016 east side Levington saltmarsh project points based on September 2015 measurements.

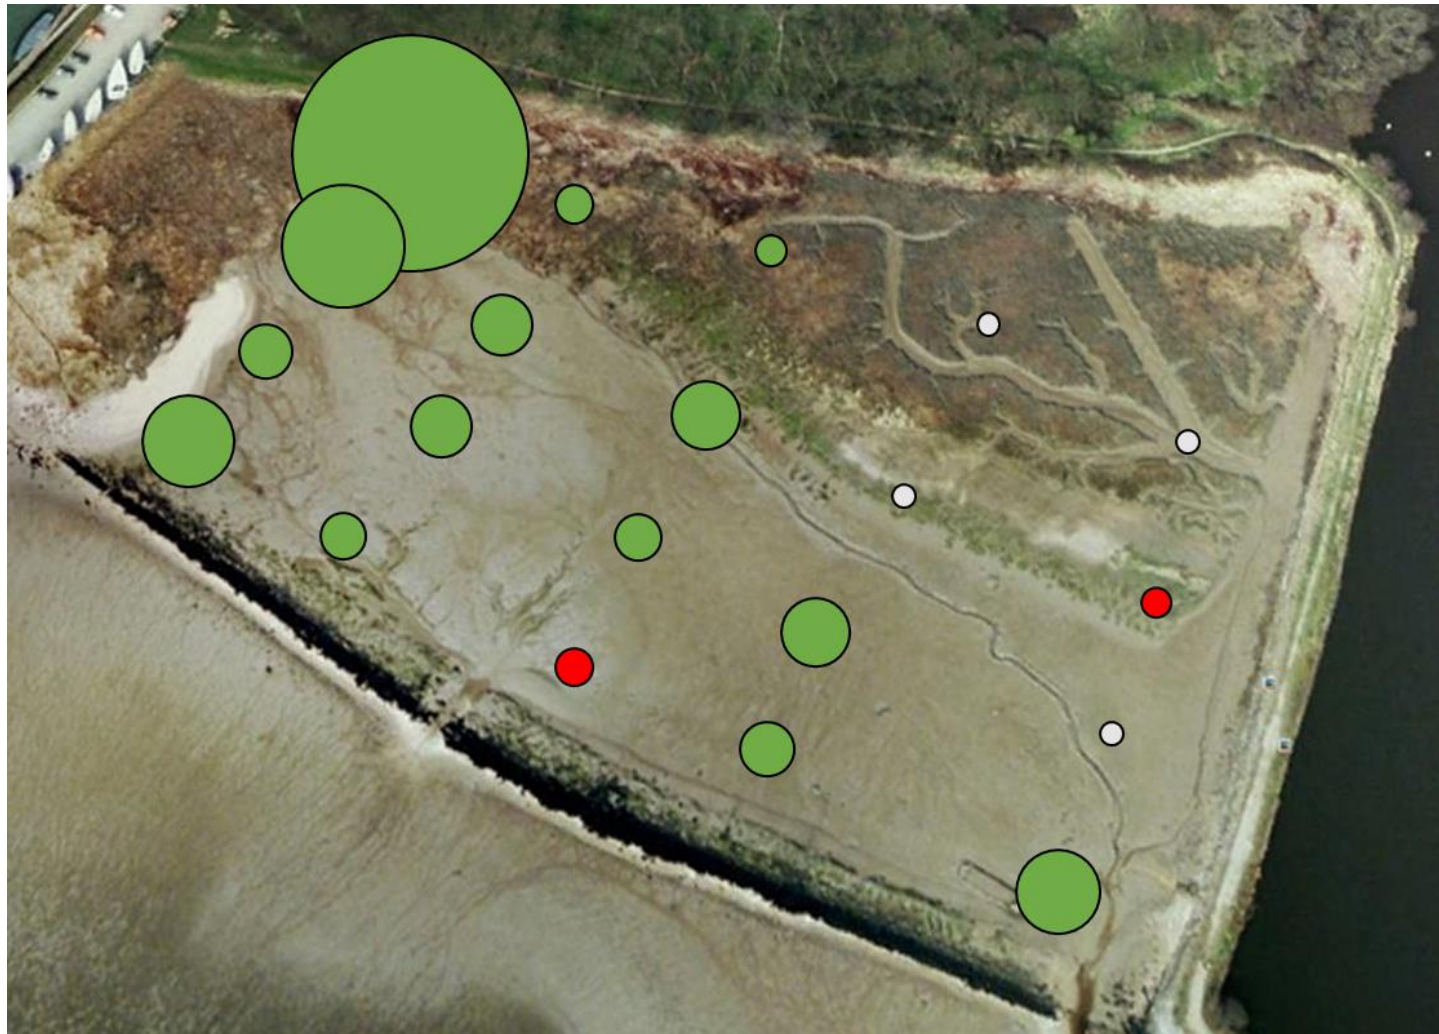
Plate 4. Current status of east side Levington saltmarsh project points based on original January 2015 measurements.

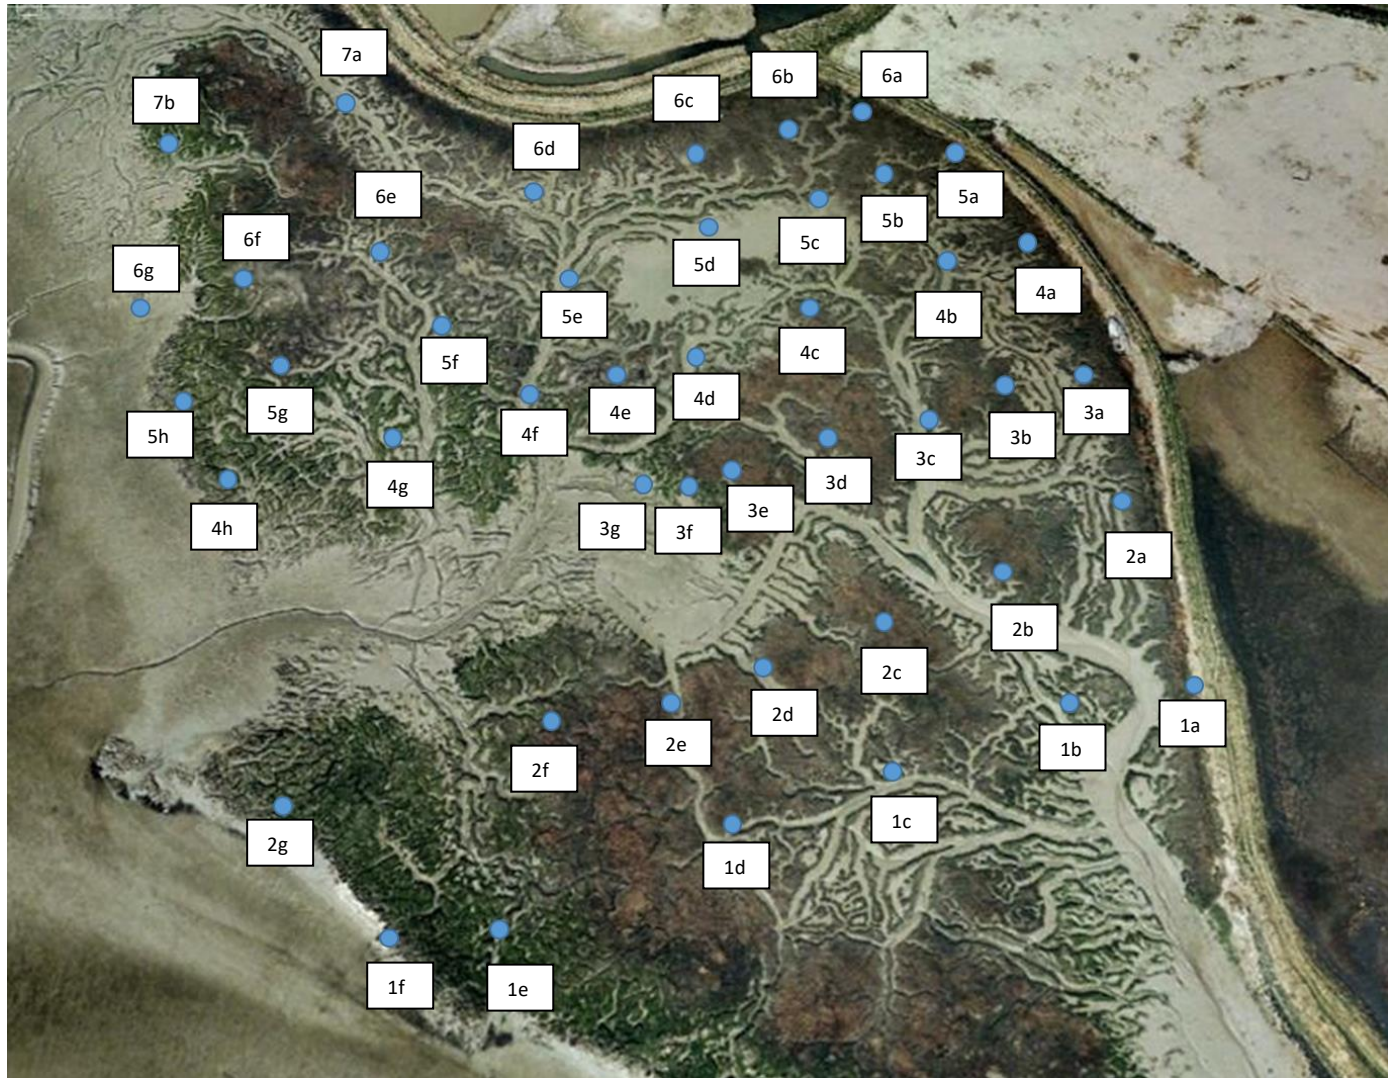
Plate 5. Location of Levington saltmarsh restoration project points – west side August 2014. All stakes set at a height of 500mm.

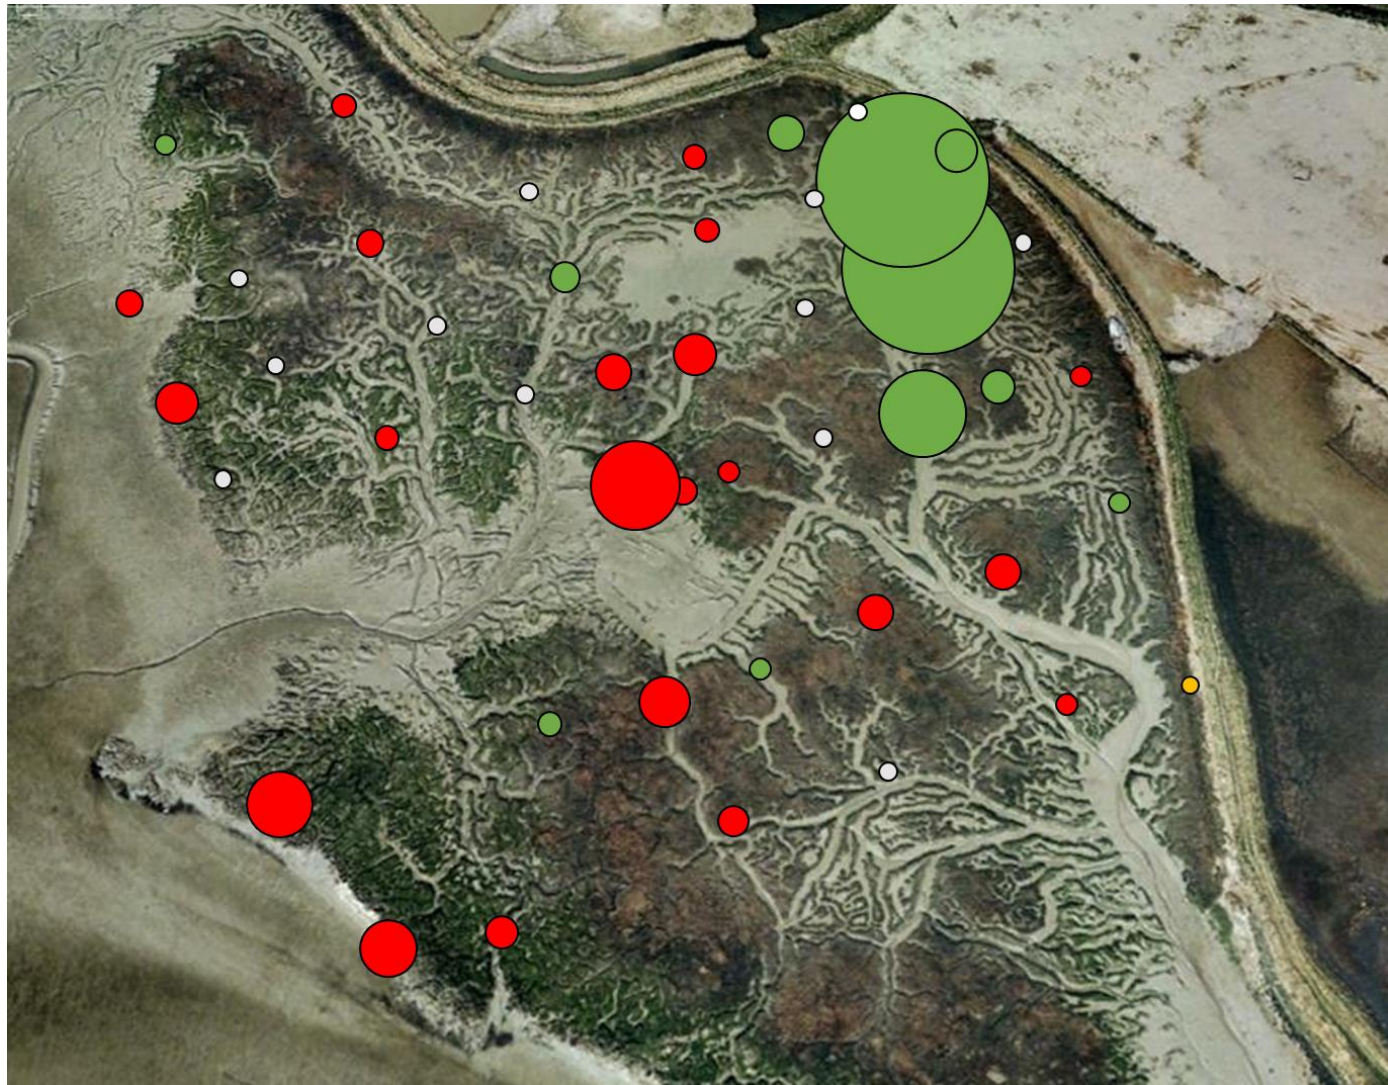
Plate 6. Status of September 2015 west side Levington saltmarsh project points based on August 2014 measurements.

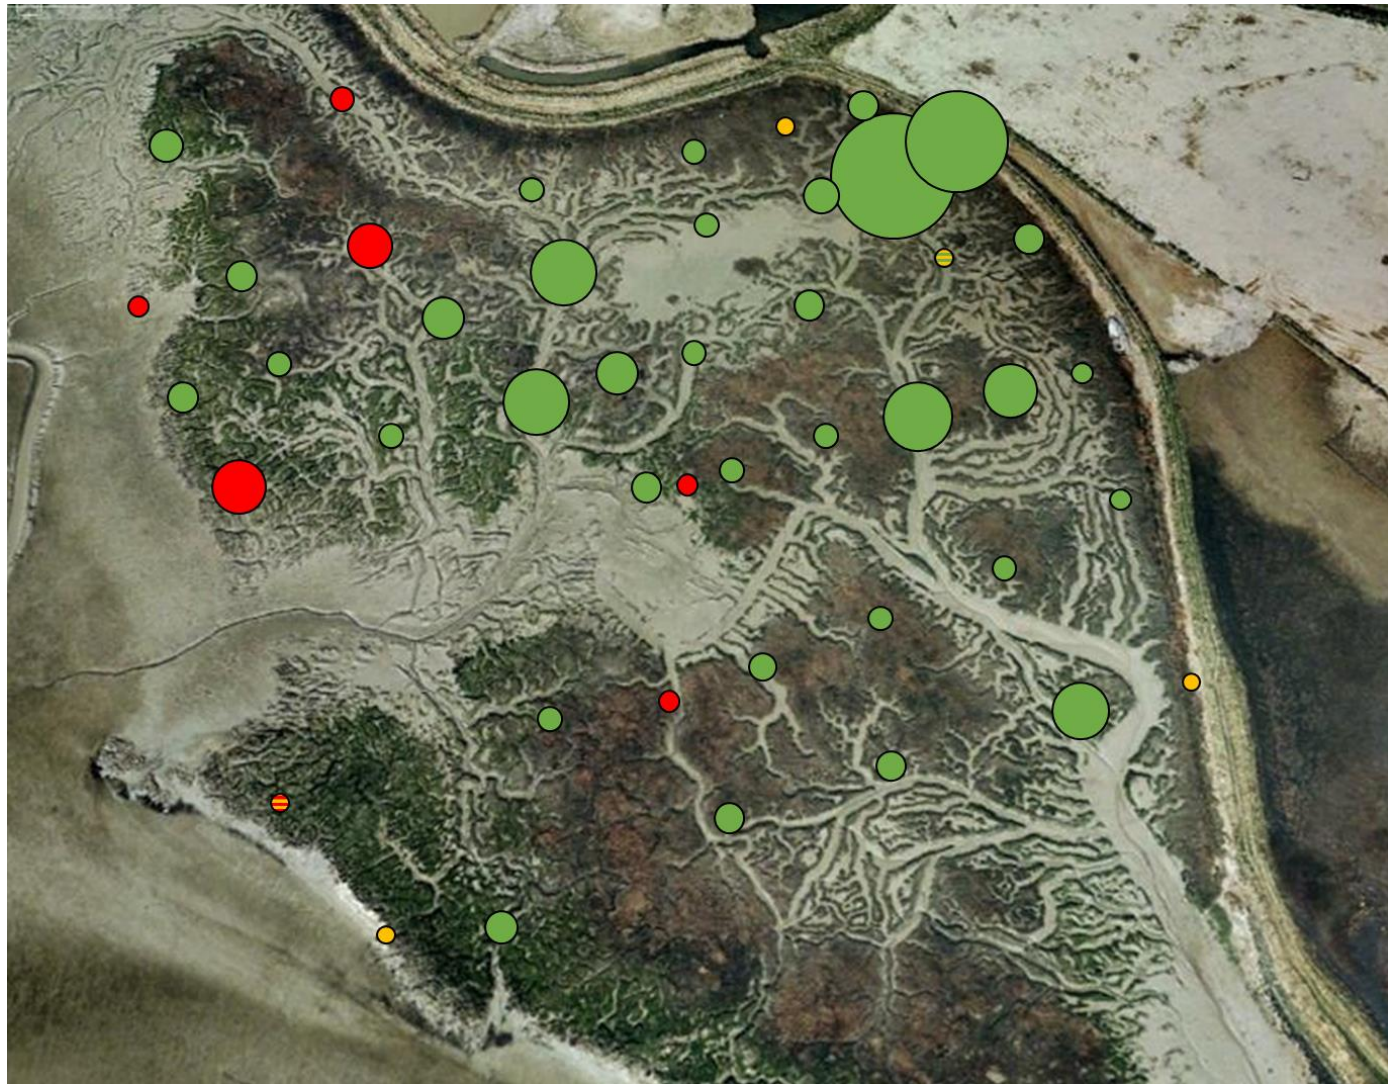
Plate 7. Status of October 2016 west side Levington saltmarsh project points based on September 2015 measurements.

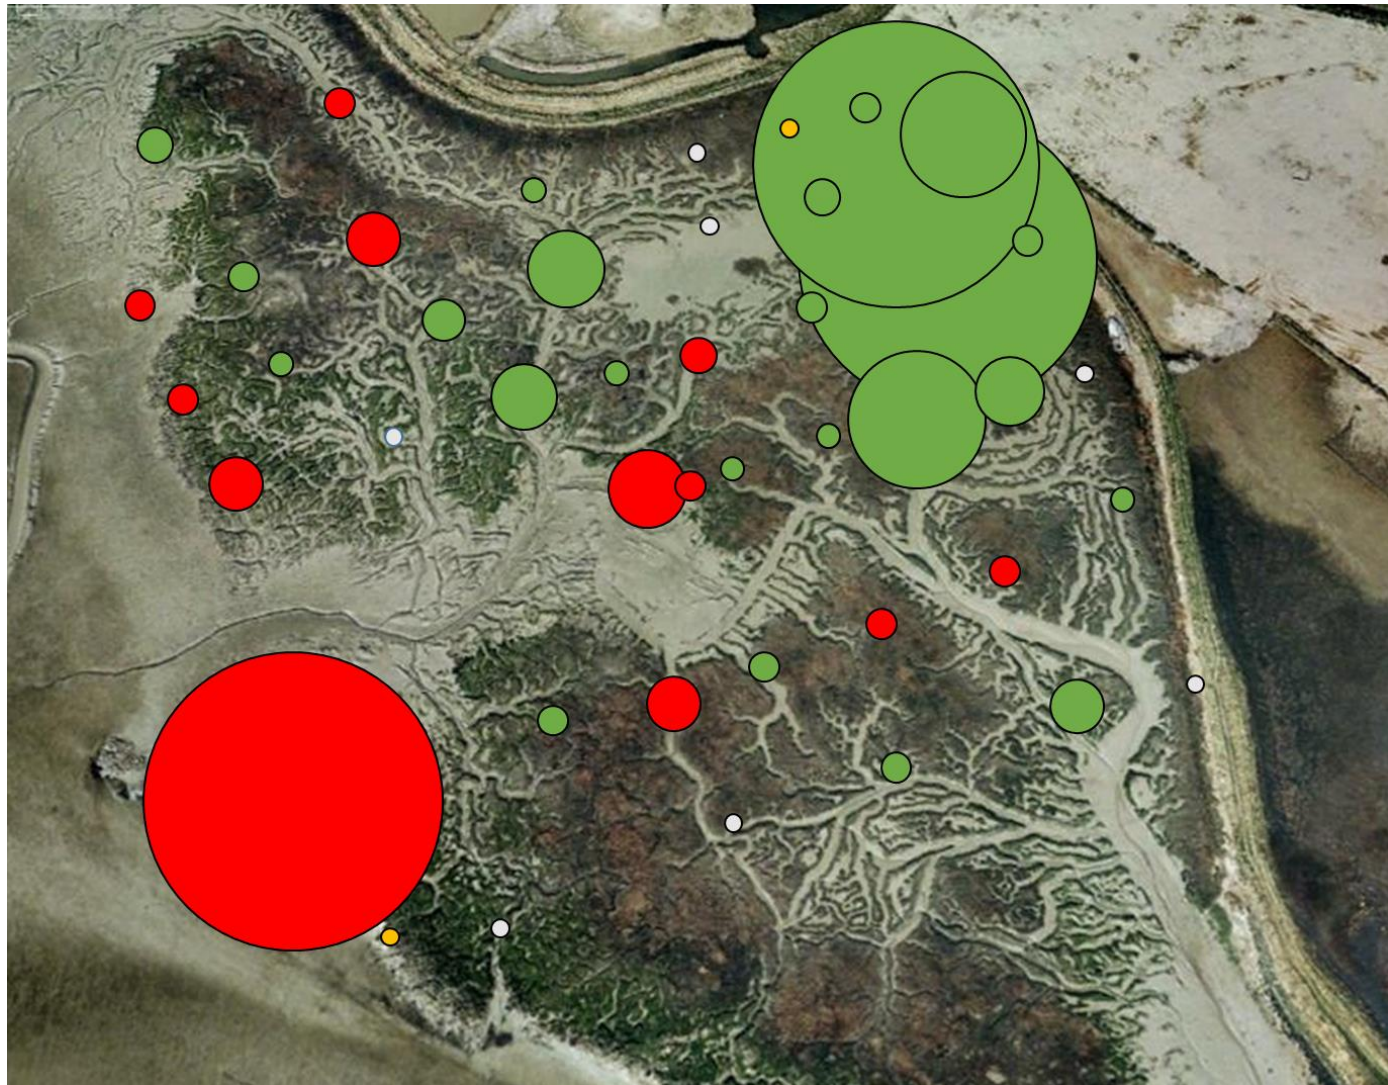
Plate 8. Current status of west side Levington saltmarsh project points based on original August 2014 measurements.
